Hydraulic and Morphological Consequences of Bank Protection Measures along the Jamuna River, Bangladesh

Synopsis

Keywords: Brahmaputra/Jamuna River, bank protection, channel stabilization, field investigation, Bandal, spur dyke

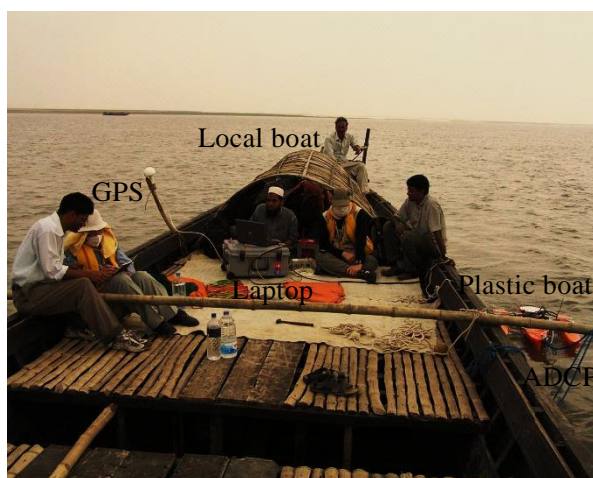
Photo1 Field survey on the Jamuna River

As a field-based applied research, field trips and field measurement systems are of great importance. In this study, a measuring system consisting of an ADCP (Acoustic Doppler Current Profiler) and a GPS (Global Positioning System) is used to record the 3D velocity vectors in the river. The ADCP (1200kHz, WH-ADCP Rio Grande by Teledyne RD Instruments) was mounted downward beneath the water surface on a particularly designed plastic boat. And the plastic boat was dragged by a local wooden boat during measurements. The ADCP and the GPS are connected with a laptop installed with a real-time data visualization and data analyzing/post-processing program. A snapshot of the field measurement is shown in Photo1, with the specifications of the measuring system.

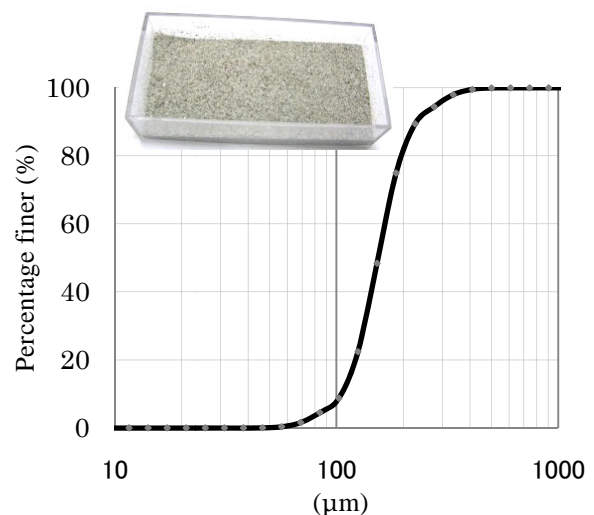
Fig.3 Sieve analysis result of sediment samples

The Jamuna River is characterized by fine sedimentary environment with highly mobile beds and banks. The sediment is uniformly graded and has very low strength and transport resistance. Mean sediment sizes of the river vary from 220μm to 165μm (FAP21, 2001), showing insignificant changes from the upstream to the downstream. Sediment samples taken from the floodplain near the Sirajganj Town were analyzed during the first field trip as shown in Fig.3. It is found obviously that the sediment is much finer than that in typical Japanese or European rivers. The mean diameter is 181μm, having a geometric deviation of 1.36.

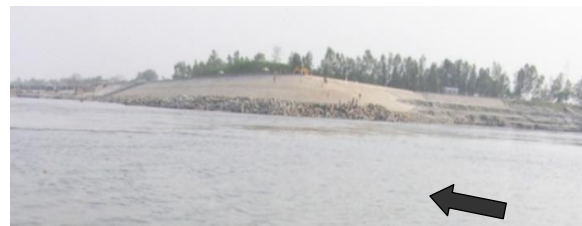
Photo 2 Sirajganji Harpoint

The old established town: Sirajganj is located in central Bangladesh, about 8km upstream of the Jamuna Bridge and about 110km northwest of the capital city: Dhaka. According to analyses results of satellite images, Sirajganj is observed to have the highest erosion rate in the catchment area (CEGIS, 2007). The erosion of the bankline since the 1950s has resulted in parts of the historic town fronting directly onto the river bank (Halcrow et al., 1994). In order to protect the town, revetment works were launched by the Bangladesh Government in 1998, known as Sirajganj Hardpoint. The hardpoint intends to control the shape of the BRE with the lowest level of intervention to the river flow. The hardpoint was constructed with cement concrete cubic blocks and consisted of a straight portion along the BRE together with a round upstream termination. The basics of the Sirajganj Hardpoint are listed in Table1 and a photo is shown in Photo2.

Length of revetment reach	2.55km
Crest level over PWD	16.75m
High flood level over PWD	15.75m
Low water level over PWD	6.80m
Apron setting level over PWD	-4.20m
Design scour level over PWD	-13.25m
Thickness of apron	1.93m
Side slope	1:3.5
Size of cement concrete block	55cm & 85cm
Completion of the hardpoint	1998

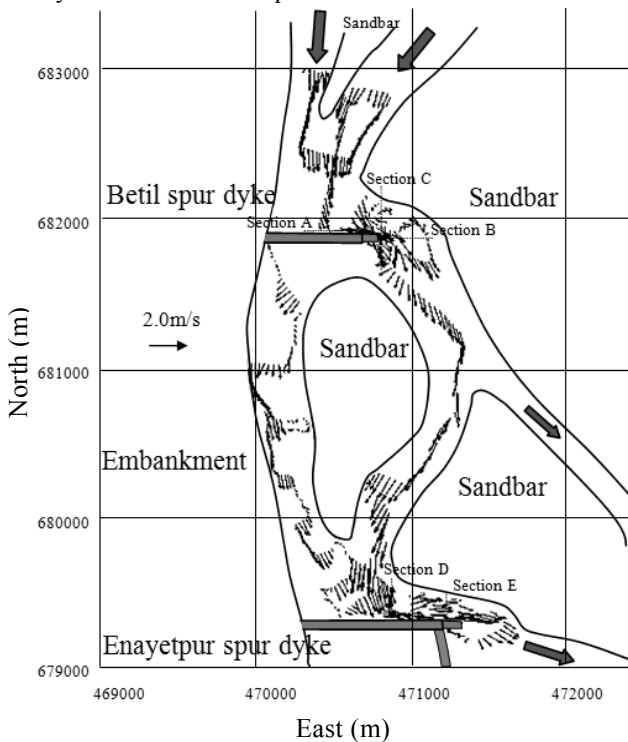
Fig.14 Velocity vectors around the Betil/Enayetpur spur dykes 0.86m beneath the water surface

The velocity field was measured on July 15, 2008 and the resulted velocity vectors in a horizontal plane near the water surface around the two spur dykes were plotted in Fig.14. Major sandbars were also sketched in the figure according to field investigations and satellite images. Due to the existence of various sandbars, the approach flow did not attack the head of either spur dyke, which made the scour phenomena around the two spur dykes somewhat unique.

When the flow approached the spur dykes, it was blocked, changed its direction paralleling to the spur dyke and flowed towards the spur dyke heads. The parallel flow had a potential to remove sediment on its way to the head which gave the

answer why severe scour took place along the earthen shank of the Enayetpur spur dyke. At the head of either spur dyke, flow circulation was recognizable although the data was not fine enough to resolve the details.

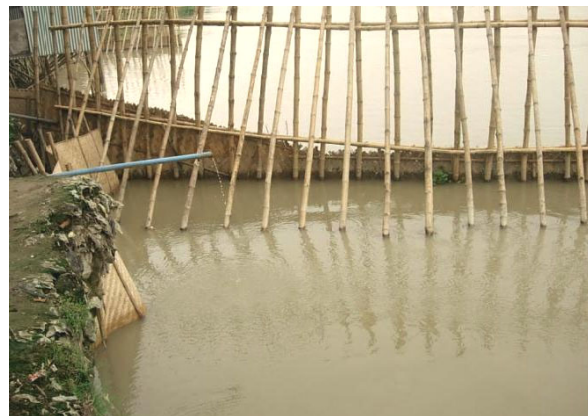
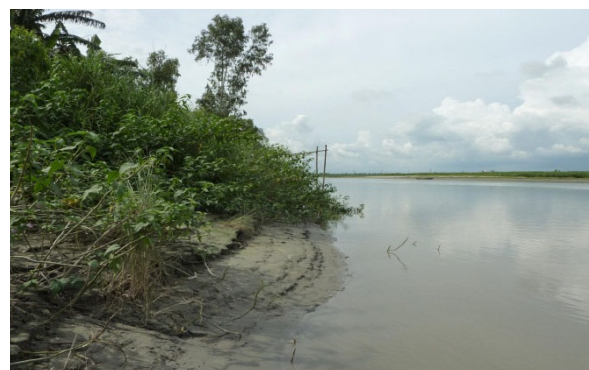
Photo 5 Randhunibari Bandal (July, 2008)

The handloom enriched Randhunibari locates along the west bank and immediately downstream of the Jamuna Bridge as shown in Fig.2. Oblique flow towards the bankline during the monsoon season put the Randhunibari market nearby in a very dangerous situation. In order to protect the bank from erosion and to test the performance of traditional river training structures, a group of Bandals was constructed by RRI (the River Research Institute) during the period of year 2007-2008. Each Bandal structure protruded into

the water course with a length of about 10m and made an angle of 50° - 60° to the bankline. The Bandal was made of groups of vertical bamboo piles with a spacing of 46cm. The diameters of the bamboo piles ranged from 6cm to 9cm. The piles were connected with each other by cross bamboos with a vertical spacing of around 75cm. Moreover, inclined bamboos were set at an angle of 45° to the bamboo piles to enhance the stability of the Bandal structure. The upper part of the Bandal was closed with bamboo thatch while the lower part is open. The Bandals were arranged in a group along the secondary channel of the river as show in Fig.2. The distance between two consecutive Bandals is around 32m. The details of one of the Bandals are shown in Photo1 which was taken during the field investigation in July, 2008. On the other hand, Photo2 demonstrates the sediment deposition behind the Bandal structure along the bank and the photo was taken in July 2009, one year after the first field trip. It is found that a large area of land is created behind the Bandal within only one year. The two photos give visible evidence on the deposition-promoting performance of the Bandals.

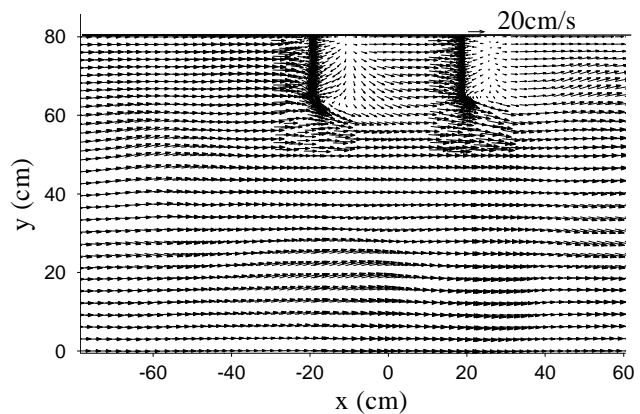
According to Fig.23 and Fig.24, it is found that the flow velocity on the water surface is affected significantly by the blockage of the upper part of the Bandal-like structures and 3D vortices in the scour. On the other hand, the flow velocity at the lower layer is closely related to the bed geometries and the existing of the piles of the Bandal-like structures. In general, the numerical model reasonably reproduces the experimental results.

If one takes a closer look at the free surface velocity field, one may note that bed morphology influences a lot on the flow structure. The flow separation angle at the head of the structure is much smaller compared with that of the PIV measurement. As has been argued in previous research (Zhang et al., 2009), the over-estimation of the current PIV method due to an over-accumulation of tracers is considered to be a probable reason. The inherent deficiency of the eddy viscosity based turbulence model is also another probable cause, but further evidences are needed.
